Final Report

May 1, 2015

# Franklin Hill / Irishtown Bend

## Stabilization and Restoration

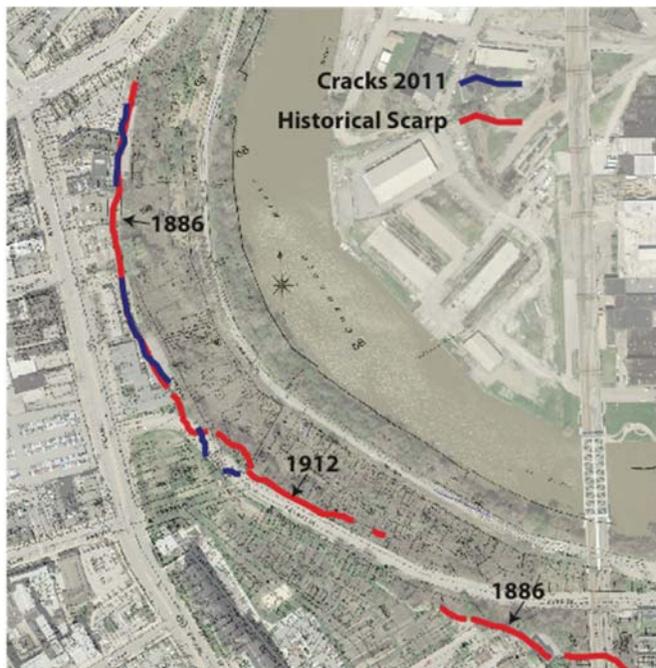
Figure 2: Historic Scarp Line Mapped by Sanborn Insurance

Franklin Avenue, parking lots and embankments were constructed over historic scarp line that was mapped by Sanborn Fire Insurance, see Figures 2 and 4 below.

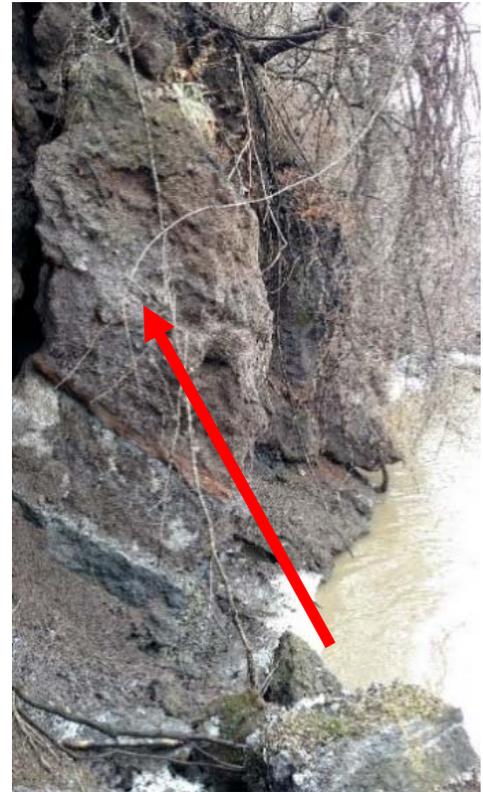
Figure 5: Soil Block Failure

Visual observation along the toe of the river identified soil block failures up to heights of 15' and tension cracks developing along the top of the riverbank as shown in Figures 5 and 6. The tension cracks will further grow as they collect water and expand under freeze and thaw cycles. The river bank failures that are occurring at the top of the slope, as shown in Figures 5 and 6, are reducing the stability of the hillside from the river's edge up to Franklin Avenue. This type of large mass soil failure at the river's edge and at the toe of the slope is further described in Appendix A and is known as a Retrogressive Slide Development. If efficient action is not implemented, the stability of the slope can be further jeopardized. Soil block failures such as shown in Figure 5 can interfere with ship traffic.

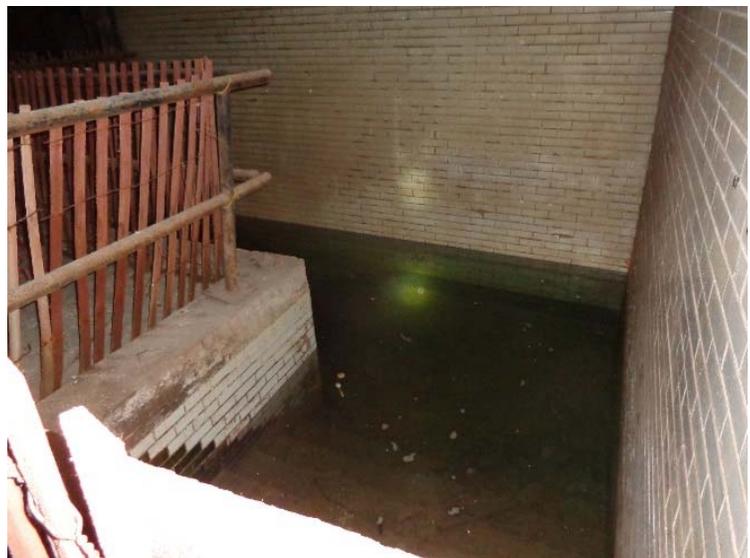
Figure 7: Bypass Tunnel Flooded with Water

It was observed during the site inspection that the West Station pedestrian bypass tunnel was flooded with water (see Figure 7). Observations of water entering the tunnel were noted in the late 1980’s by Cuyahoga Bridge Inspectors. It is unlikely that the tunnel would have been constructed below the groundwater elevation without means of dewatering, since the primary purpose of the tunnel was to allow subway passengers to safely cross under the railroad tracks to access the restrooms.

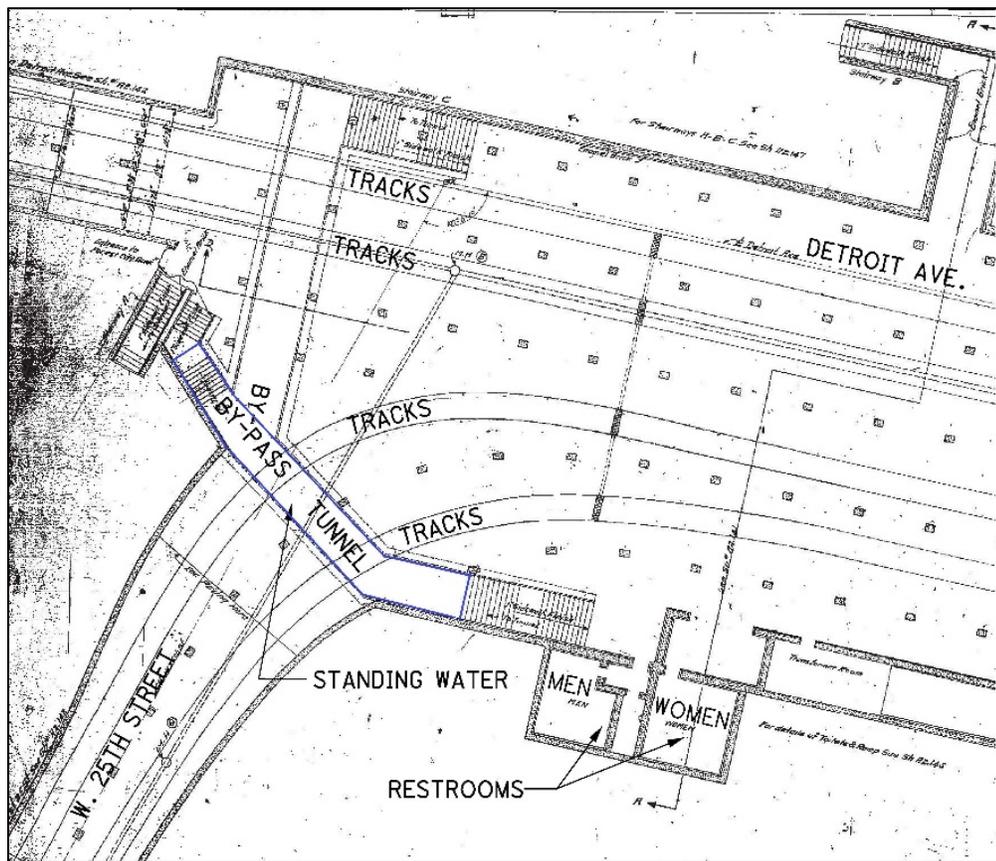
Figure 8: Pedestrian Bypass Tunnel Layout

Figure 8 shows the layout of the pedestrian bypass tunnel in relation to the access to the restrooms. The standing water at this elevation is approximately 20' below the existing grade of Detroit Avenue near the intersection of West 25<sup>th</sup> Street. Although groundwater elevations can fluctuate, an extensive sampling and groundwater monitoring program was conducted south of the tunnel system at 1477 West 25<sup>th</sup> Street between 1999 and 2006 by Hull & Associates and Delta Environmental Consultants. There are more than 25 monitoring wells installed at the property (see Figure 9) for evaluation of the groundwater associated with the underground storage tanks at this site. The groundwater depth measurements averaged 29' below grade, and the closest wells to the tunnel systems, MW-24 and MW-25, were 30.5' and 29' respectively. Therefore, there is a 10' +/- water elevation difference between the monitoring wells and the standing water in the bypass tunnel system. This means that the water in the tunnel is 10' higher than the natural groundwater, indicating an unexplained elevated water condition.

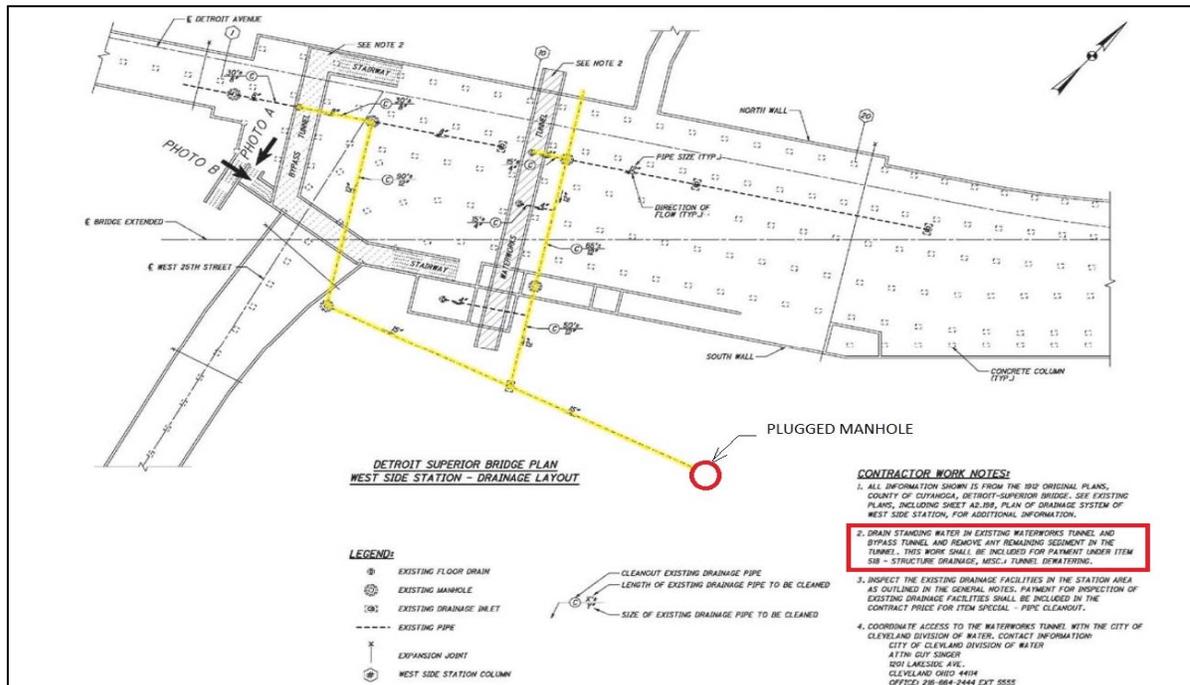
Figure 11: 2014 Project Plan Sheet from CUY-6-14.56

Figure 11 is from the recent construction project, CUY-6-14.56 PID No. 77040, which is primarily a concrete rehabilitation of the Detroit-Superior Avenue Bridge. The highlighted conduits for each tunnel system are connected at a drainage structure that flows to a manhole that should outlet to the Cuyahoga River. However, that manhole is partially plugged and does not allow drainage of the tunnel systems. The plugged manhole (which is shown in Figures 11 and 14) is approximately 40' deep and has 20' of standing water in it. An attempt was made to dewater the manhole in conjunction with the contractor dewatering of the pedestrian bypass tunnel, per Item 2 in the highlighted construction work notes in Figure 11. The water in the manhole was lowered by 8' in one week of pumping and the contractor was able to partially dewater the pedestrian tunnel. However, complete dewatering of either structure was never achieved.

**Figure 11, Contractor Work Note 2:** Drain standing water in existing waterworks tunnel and bypass tunnel and remove any remaining sediment in the tunnel. This work shall be included for payment under Item 518 – Structure Drainage, Misc., Tunnel Dewatering.

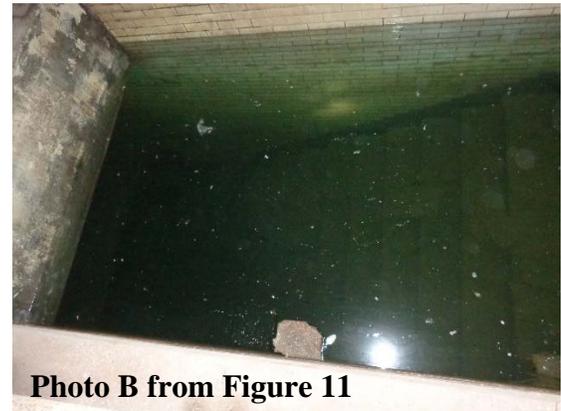
Photo B from Figure 11

The contractor hired by ODOT for CUY-6-14.56 also made an attempt at dewatering the tunnel but could only reduce the water elevation by approximately 2'-4'. A section view of the tunnel is shown in Figure 13. ODOT decided to abandon the operation and cease the work associated with draining and inspecting these tunnel systems. Inspection of the waterworks tunnel could not be performed for this phase because access was blocked and flooded with high pressure water.

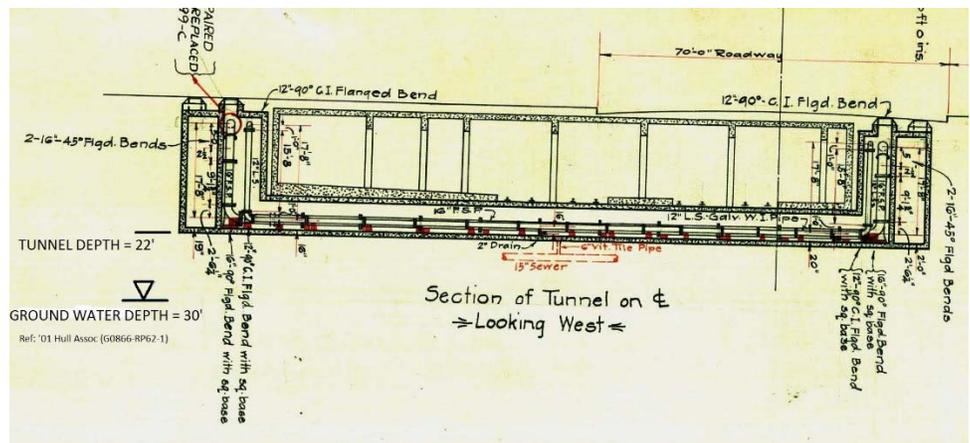
Figure 13: Section View of the Tunnel

The fact that the tunnels have a combined drainage system that share an outlet that is partially plugged allows water to back up into the tunnel systems. Therefore, the tunnels serve as large holding reservoirs allowing water to slowly discharge through the partially plugged manhole.

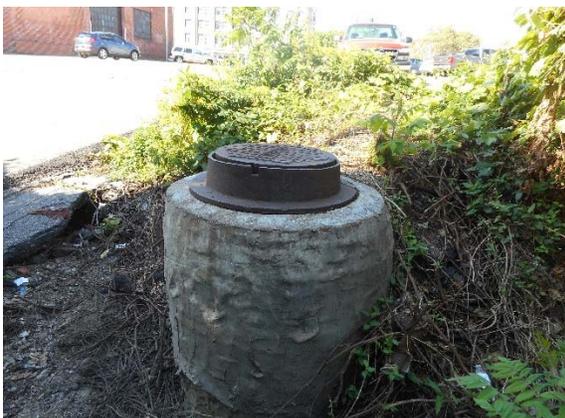
Figure 14: Partially Plugged Manhole as shown in Figure 11

An attempt to dewater the partially plugged manhole that is connected to the tunnel system was made between May 5, 2014 and May 9, 2014. The depth of water in this manhole during the time of inspections was consistently 20' and the bottom of the manhole is approximately 40' deep. The process of dewatering the manhole with a trash pump was ceased because of the lack of advancement to lower the water by more than 8'. Subsequently, a 4,000 Gallon VAC-Truck was mobilized to the site to try to dewater and clean the debris and sediment from the bottom of the manhole. After two days of operations and three full disposals of water and sediment, the operation was halted because of lack of progress to dewater the structure. Therefore, the condition assessment of the storm conduits draining into this system from the tunnels could not be made.

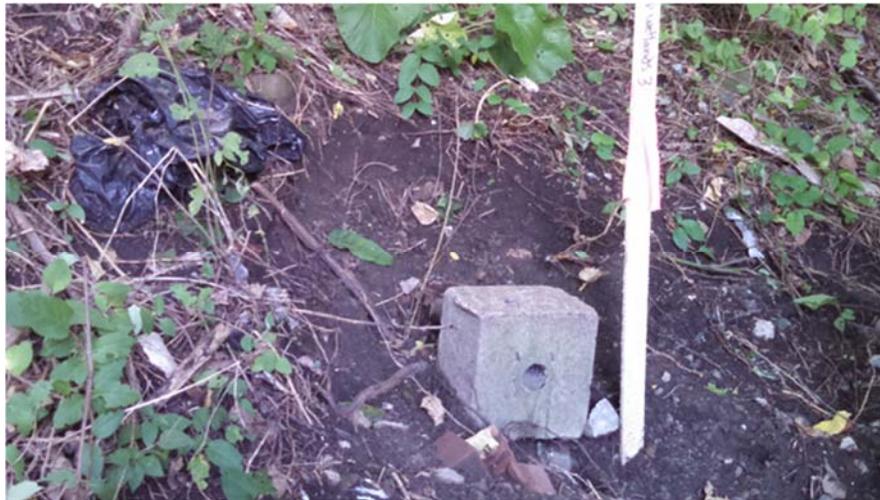
Figure 16: Horizontal 2" Diameter Drain Pipes Installed in 1966

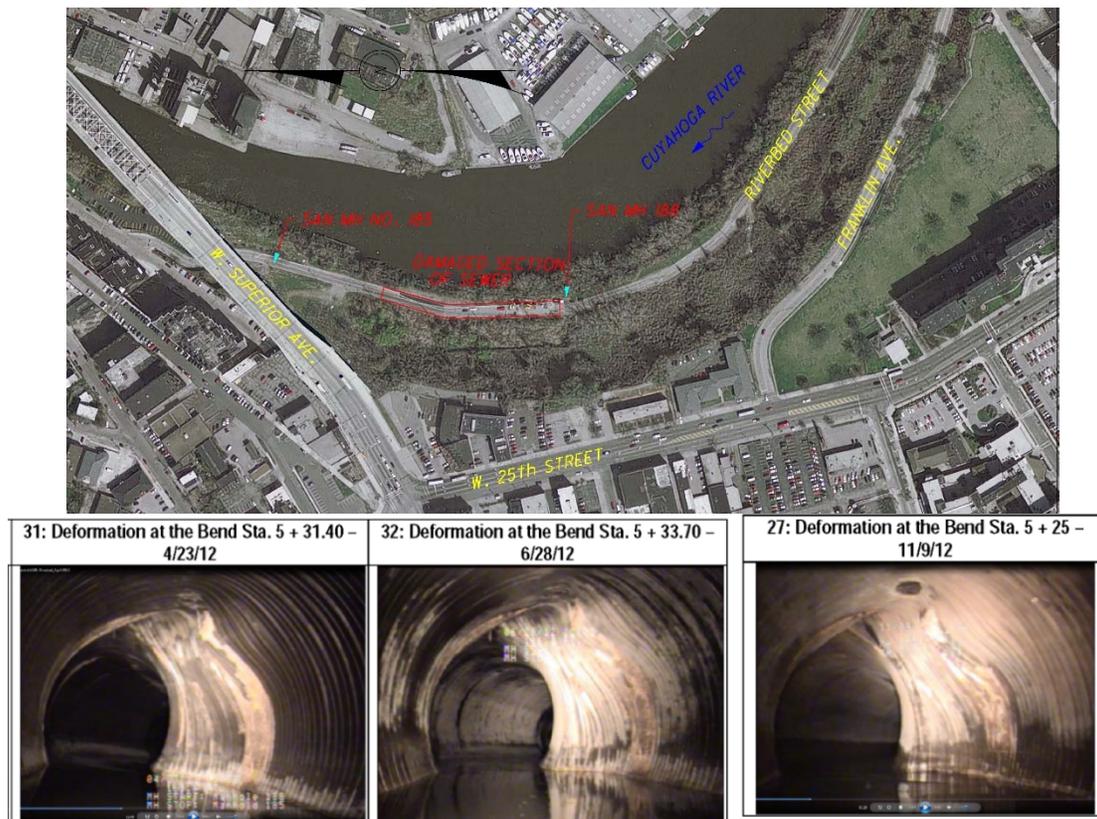
Figure 17: Section of Sanitary Line Under Most Distress

The Northeast Ohio Regional Sewer District (NEORS) maintains a 60” brick sanitary sewer known as the Westerly Low Level Interceptor (WLLI) through the project limits of the site. The alignment closely follows Riverbed Street and the depth of cover varies from 30’ - 40’. The flow is from south to north toward the Division Avenue Pump Station that carries the sewage to the Westerly Wastewater Treatment Plant. The condition of the sanitary line was compromised in two local slips along Riverbed Street in January and August of 2006. An emergency repair project was conducted in 2007 that installed a 42” and 50” spiral wound grouted sleeve between Sanitary Manholes 185 and 190. Also, a 12” to 16” bypass system was installed in case of future failures along Riverbed Street. NEORS routinely monitors this section of sewer with video inspections conducted approximately every six months. Review of the video indicates that the lining has deformed between the 2012 and 2013 inspections. It appears that the section under most distress is the section highlighted in Figure 17, with maximum deformation of the lining occurring in the horizontal deflection of the alignment.

The remaining length of the sewer appears to be stable and functioning as designed. The section between Manholes 185 and 188 is approximately 700' and could be replaced in conjunction with the installation of the bulkhead system. There would be advantages to combining the construction of the tieback system with the required excavation to expose and replace the damaged section of the sanitary line. In essence, the sheet piling designed for the bulkhead deadman system could function as a shoring system so that conventional trench boxes could be used for replacement of the line as shown in Figure 22. The bypass system already in place could be used to divert flow during the replacement process. The approach and design would require close coordination with NEORS staff. Coordinating efforts to repair the WLLI with stabilizing the hillside will reduce total cost and time necessary for global improvement to the site.

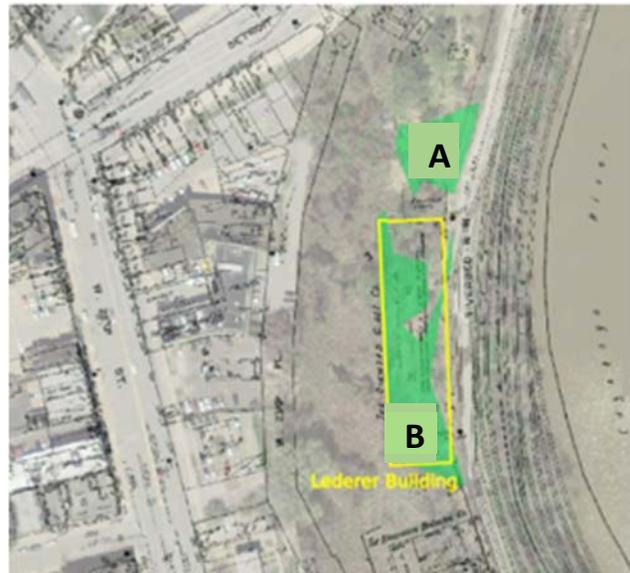
Figure 19: Mapped Wetland Areas A and B

It is clear from overlaying the survey mapping with the wetland delineation that Wetland A resides at the bottom of a concrete drainage chute that was constructed in 1966 to carry parking lot surface drainage to the toe of the slope. The condition of the concrete chute has deteriorated, however there is a natural swale that has developed that carries parking lot and slope drainage to Wetland A. The overlay of the map also helps identify the water source for Wetland B. The area associated with this wetland is within the confines of the foundation remnants of the Lederer building. As shown in Figure 20, the Lederer building foundation is trapping water and creating a pond effect enabling wetland vegetation to grow and hydric soils to develop.

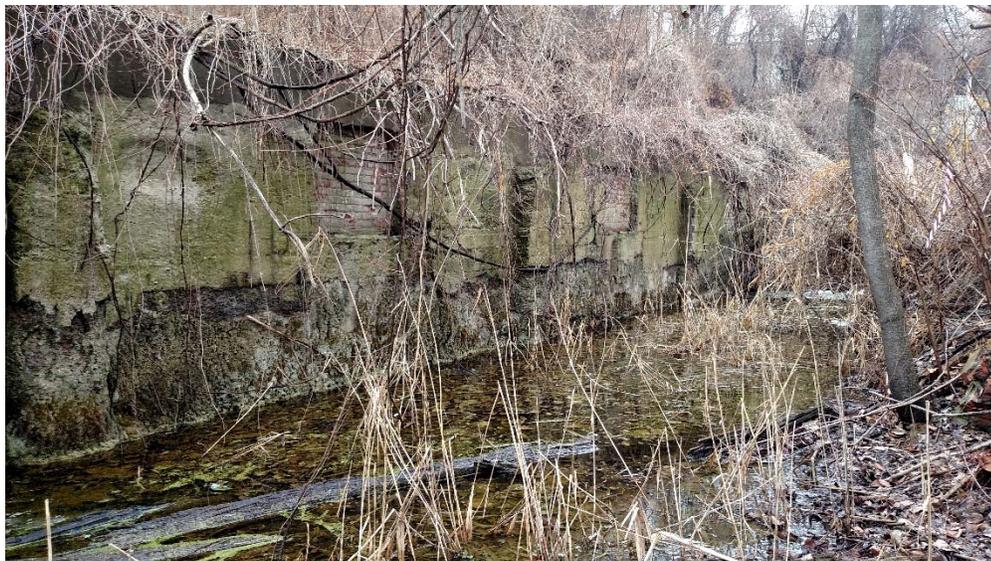
Figure 20: Lederer Building Foundation (Trapping Water)
