Final Report

May 1, 2015

# Franklin Hill / Irishtown Bend

## Stabilization and Restoration

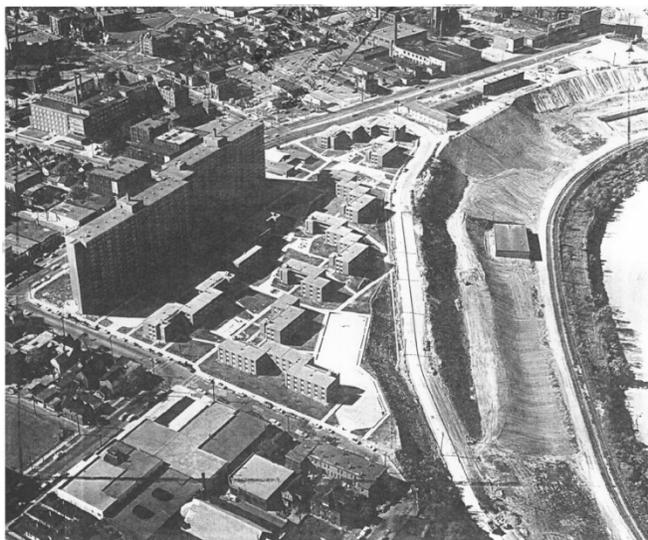
Figure 4: Graded Site with Realigned Franklin Avenue

The finding of categorized wetlands was not anticipated due to the past industrial use of the site and lack of native species that would exist after the significant grading conducted in the 1960’s (see Figure 4). For a wetland, supporting vegetation and hydric soils need to exist, and the site needs to have a continual water source to support non-native vegetation and soil conditions. Therefore, our investigation focused on the water supply to these two areas.

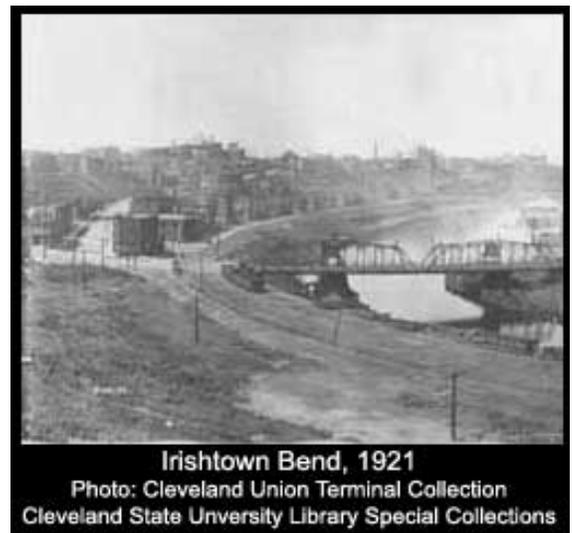
Figure 3: Irishtown Bend Industry

Before dredging activities took place in the 1920's, the Cuyahoga River was only 8' to 10' deep. The original mouth to Lake Erie was located approximately 4,000' to the west of its current location. Figure 3 depicts the development along the hillside; note the narrow width of the river at the Columbus Road crossing. The Cuyahoga River is now dredged to a depth of 23' and widened in some sections to allow passage of freighters. The Irishtown Bend is a very difficult passageway for freighters to navigate. The ships use the full width of the river to navigate the turn and therefore transmit high lateral forces to the outer bend of the river's edge from the use of bow thrusters.

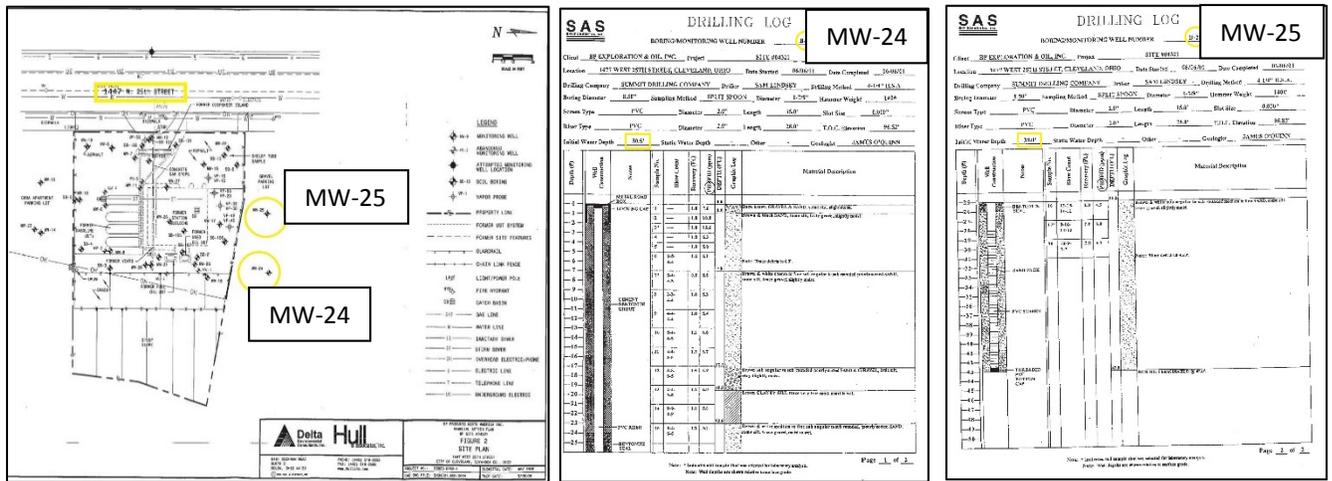
Figure 9: Monitoring Wells

Figure 8 shows the layout of the pedestrian bypass tunnel in relation to the access to the restrooms. The standing water at this elevation is approximately 20' below the existing grade of Detroit Avenue near the intersection of West 25<sup>th</sup> Street. Although groundwater elevations can fluctuate, an extensive sampling and groundwater monitoring program was conducted south of the tunnel system at 1477 West 25<sup>th</sup> Street between 1999 and 2006 by Hull & Associates and Delta Environmental Consultants. There are more than 25 monitoring wells installed at the property (see Figure 9) for evaluation of the groundwater associated with the underground storage tanks at this site. The groundwater depth measurements averaged 29' below grade, and the closest wells to the tunnel systems, MW-24 and MW-25, were 30.5' and 29' respectively. Therefore, there is a 10' +/- water elevation difference between the monitoring wells and the standing water in the bypass tunnel system. This means that the water in the tunnel is 10' higher than the natural groundwater, indicating an unexplained elevated water condition.

A likely explanation for the water elevation difference can be the presence of two water main systems, 12" and 16" diameter lines, which run parallel to West 25<sup>th</sup> Street and cross under Detroit Avenue through a waterworks tunnel that was constructed under the subway railroad track line. The alignment of the water mains is shown in Figure 10.

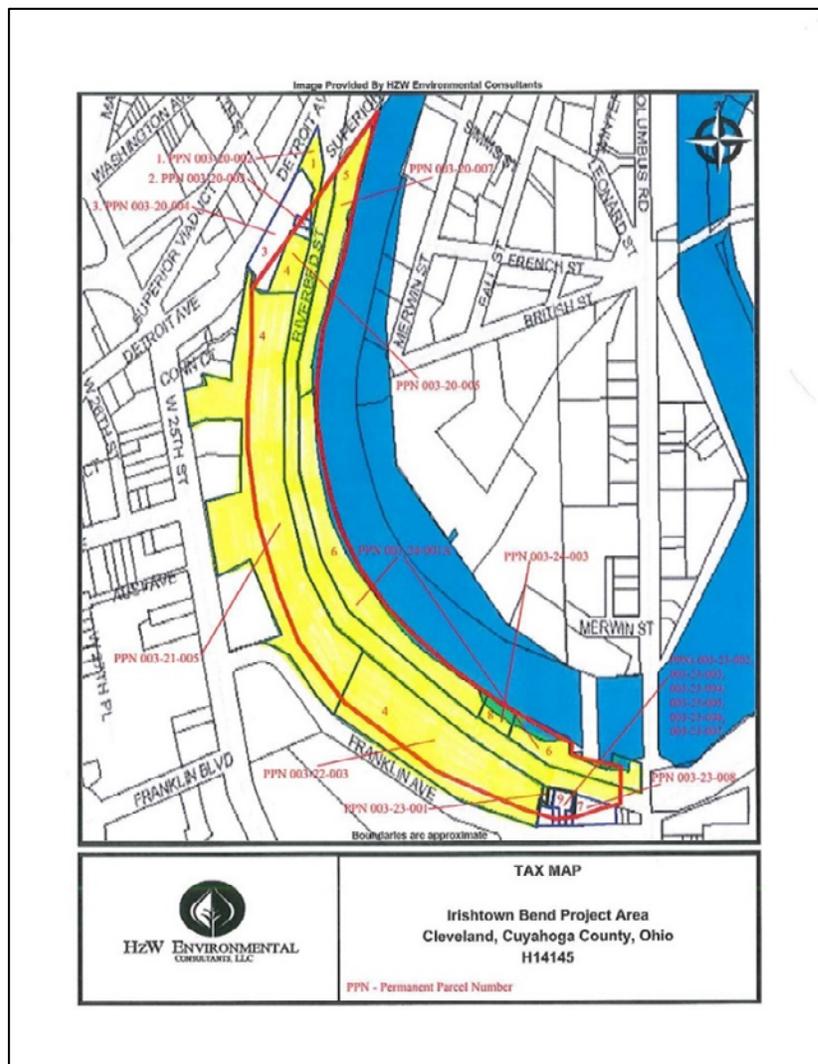
Figure 18: Property Map

- Property 6: Consists of densely wooded land that slopes to the east-northeast towards the Cuyahoga River. Based on the historic development of Property #6 with railroad tracks and coal transportation operations, this parcel is recommended for inclusion in Phase II ESA activities, as a majority of this site will be affected by the bulkhead installation.
- Parcel 8: Consists of wooded land that slopes to the northeast towards the Cuyahoga River. Based on the historic development of Property #8 with railroad tracks and coal transportation operations, this parcel is recommended for inclusion in Phase II ESA activities, as a majority of this site will be affected by the bulkhead installation.

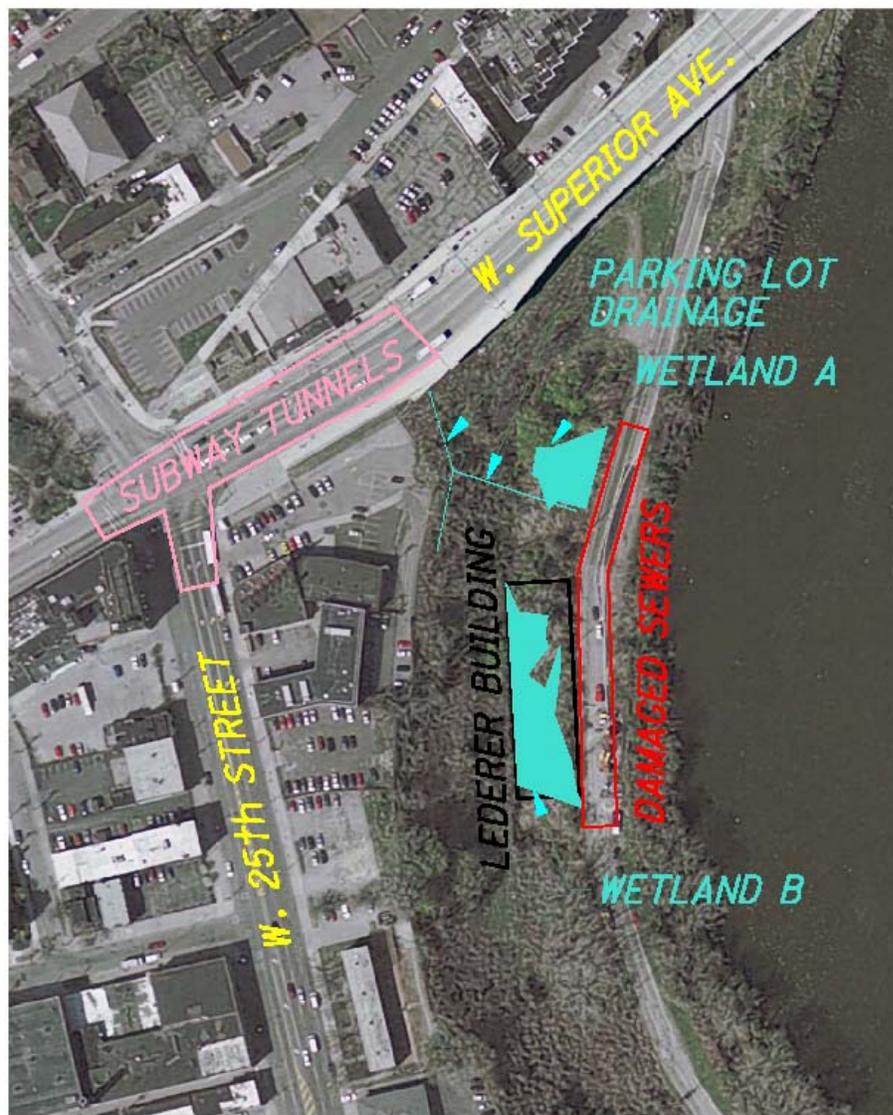
Figure 21: Combined Location Map – North End

The result of the presence of two wetlands within the project area that exceeds 0.5 acres means that completion of a USACE Section 404 Individual Permit and an OEPA Section 401 Water Quality Certification will be required prior to remediation of the site. However, if the source of water that feeds the soil and vegetation can be eliminated and the presence of each are reduced, then wetland permits may not be necessary.
